EVALUATION OF
SETTLEMENTS AT THE
CONQUISTA TAILINGS
IMPOUNDMENT

Thesis

Master of Science in Engineering

The University of Texas at Austin
December 2012

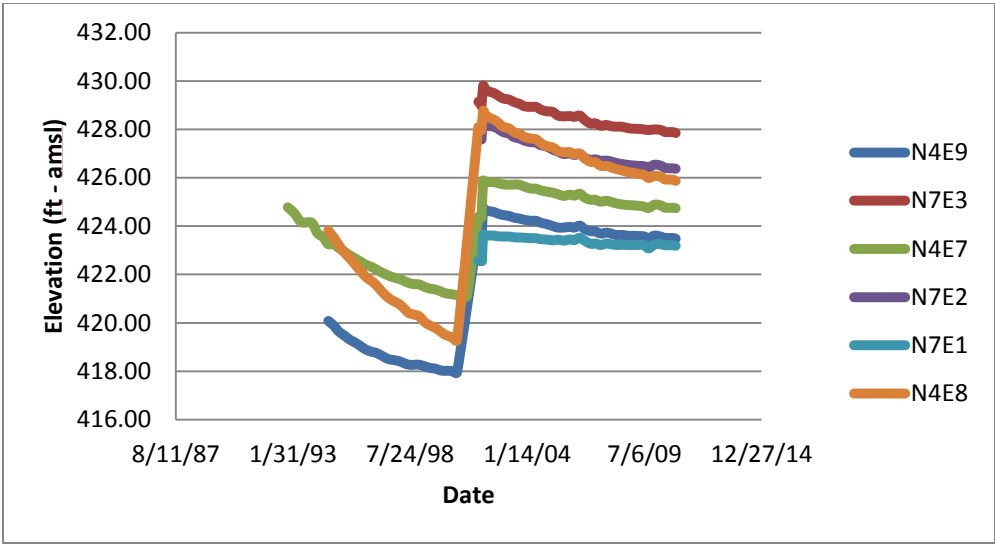
Beginning in 1993, after the final cover system was installed, settlement data was collected in the field. FIGURE 12 shows ground surface elevations (AMSL) versus time at the locations of interest, FIGURE 11.

As well as depicting the ground surface elevations, FIGURE 12 shows the additional lifts added in the attempt to mitigate the settlement that accumulated and bring the ground elevation back to grade. It can be seen that in 2001 a lift of five (5) to ten (10) feet was placed in the area of the settlement monument

locations. The lift was added to fill in the areas that amassed the most settlement throughout the previous ten (10) years. The added load created by the weight of the soil caused the consolidation process to continue, and therefore increased ultimate settlement (Tetra Tech, Inc., 2004).

FIGURE 12 – Ground Surface Elevations

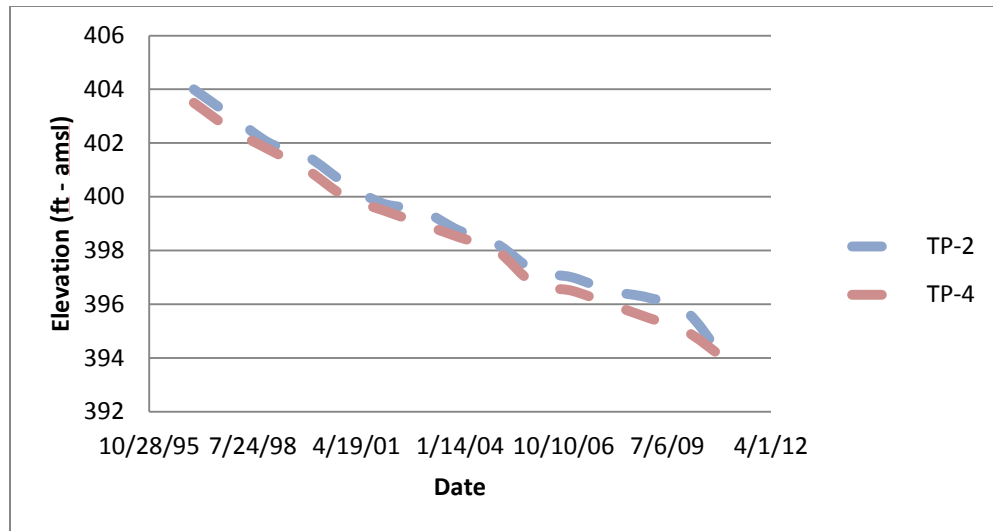
The elevation of the perched water table in the eastern portion of tailings is monitored by TP-2 and TP-4, with screen intervals of 24.2 - 34.2 feet and 24.9 - 34.9 feet below the ground surface, respectively. These wells have steadily decreased since installation. TP-2, which is located in the northern area of the eastern tailings has decreased from a maximum level of 404 feet above mean sea level to 394.25 feet above mean sea level. TP-4, located in the southern area of the eastern tailings has followed suit and decreased from a maximum level of 403.5 feet above mean sea level to 394.25 feet above mean sea level. FIGURE 14

shows the ground water elevation within the eastern tailings, TP-2 and TP-4 (Tetra Tech, Inc., 2011).

FIGURE 14 – Perched Water Table Elevations Within Tailings

As the elevation of the perched water table within the tailings is lowered, the buoyancy of the soil is reduced and the additional weight created by this effect is carried by the soil below. This loading effect is the final component that will contribute to the settlement of the tailing material. As the water table lowers, the weight and pressure acting vertically on the soil increases, which will create an increase in settlement due to the consolidation of the material (Tetra Tech, Inc., 2011). An additional assessment has been performed in case additional fill will be needed to bring the surface elevation back to the original grade of 422 feet above mean sea level. For the consolidation analysis, three (3) loading sources have been

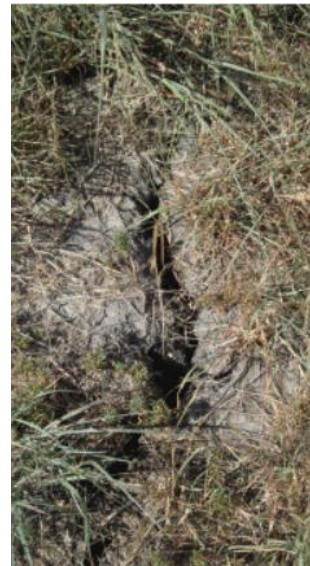
On May 29th, 2012, Todd Sheridan, Dr. Zornberg (University of Texas – Austin), and Michael Pimentel (TCEQ) visited with Ernest King, the site manager, at the impoundment in Karnes County, TX. During the site visit the settlement monuments were located and the local conditions of the site were observed. While walking the eastern portion of the site, it was easily visible that large cracks were forming at the surface. The cracks that were observed (FIGURE 15) ranged from 5-14 inches in length and between 2-4 inches in thickness. One crack was seen to extend more than twelve (12) inches below the ground surface. These cracks could not be found on the western area of the impoundment. These cracks could lead to problems affecting the integrity and structure of the liner.

FIGURE 15 – Picture of Soil Cracks in Eastern Portion (Picture From Site Visit)

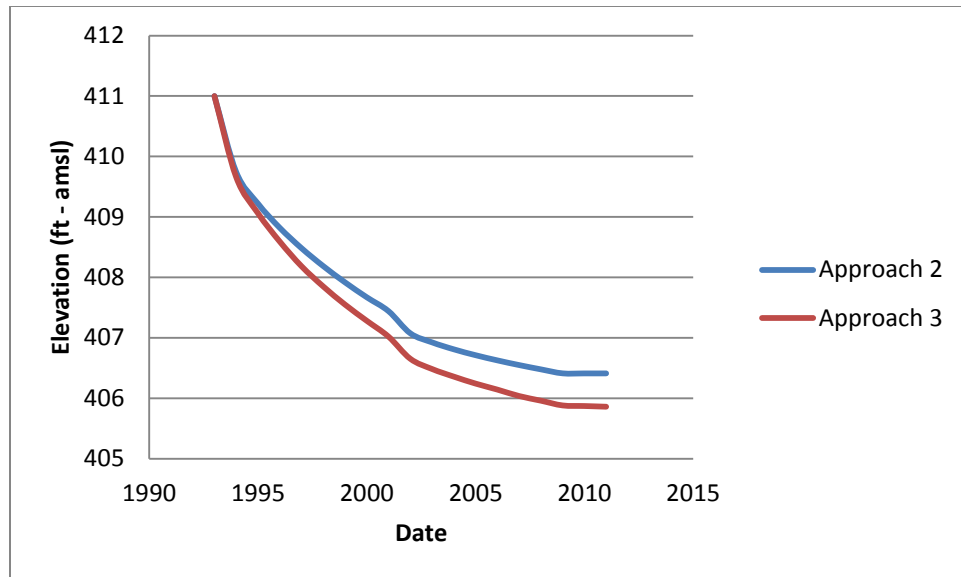
Since Approach 1 has been found to more accurately calculate the settlement caused by the lowering of the water table, and Approach 2 was structured to more accurately define the settlement caused by the loading of the soil, the combination of these key aspects from each approach will allow the total calculations to account for the three loading systems. When combining the two approaches, the settlement caused by the surface loading (Approach 2 – Figure 19) will be added to the settlement caused solely by the drop in elevation of the water table (Approach 1 – FIGURE 16). FIGURE 21 plots Approach 2 and Approach 3. FIGURE 22 plots Approach 3 compared to the data from N4E7's settlement monument.

The settlement achieved in Approach 3 corresponds very well to the settlement data prior to the fill placement in 2001. From 2001 to 2010 the calculated settlement overestimates the actual settlement experienced in the field. This can be attributed to the assumption that C_c remains constant throughout time or the amount of excess pore pressures existing within the tailings. Further testing of the tailings will refine the parameters used in the calculations and will allow for more accurate calculations.

FIGURE 21 - Approach 2 and Approach 3

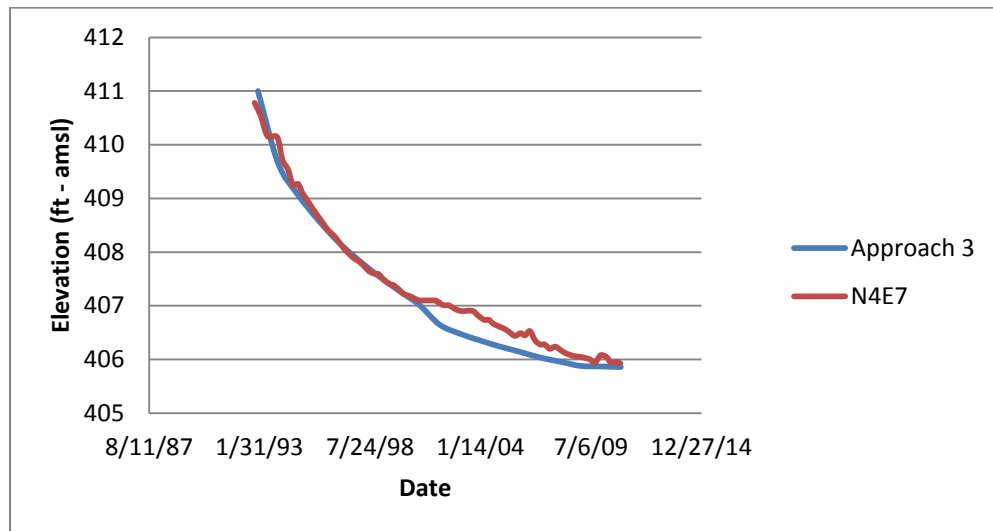
FIGURE 22 - Approach 3 with N4E7 Settlement Monument Data

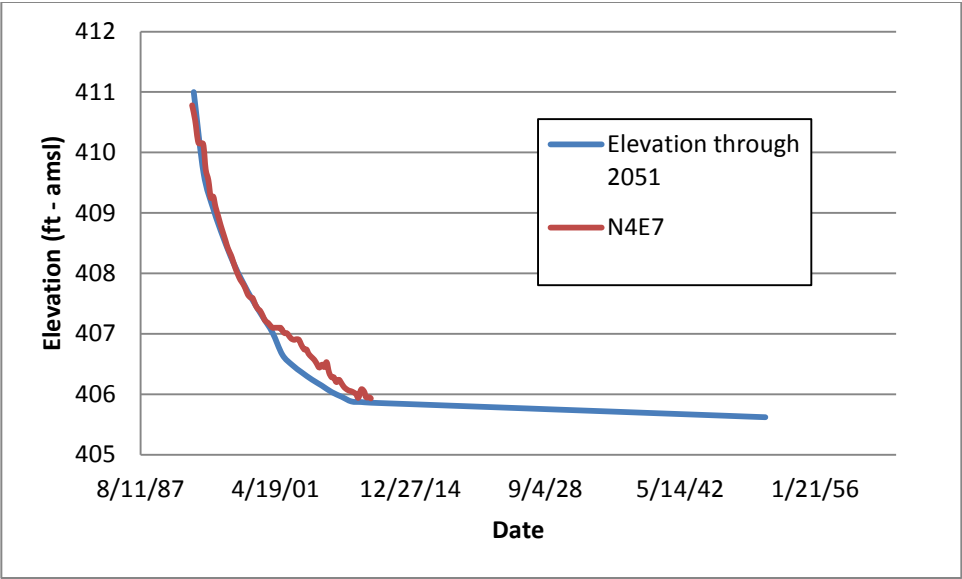
Approach 2 indicates that the settlement caused by the second cover has completed and the remaining settlement will be caused by the lowering of the water table. Assuming the parameters of consolidation and rate of water table reduction (0.5 ft/yr) remain constant with the continued settlement the settlement is projected to be completed in 2051 with an additional settlement of 0.24 feet to a final tailings surface elevation of 405.62 feet. FIGURE 23A shows the current N4E7 settlement data along with the settlement through 2051. This prediction is based solely on the fact that there will be no additional loading sequences placed at the surface and that the water table will continue to drop to the base of the tailings. The remaining settlement will then be due to the final consolidation of the tailings, due in part to the drop in the water table. In the case of an additional six (6) feet of fill placed the final settlement is reflected in FIGURE 23B and it increase the total settlement by 0.33 feet and will bring the final tailings surface elevation to 405.29 feet above mean sea level. Because the assumption that the fill will not compress or settle was used, the 20 feet of fill above the tailings surface (10-foot thick fill and cover system , 5-foot thick fill in 2001, 6-foot thick additional fill in 2014) the final surface elevation will be close to 426.29 feet amsl depending on the actual thickness of the material.

FIGURE 23A - Ultimate Settlements (Through 2051)
